Implementation and monitoring of soil and water conservation measures in the Guadalentin (Spain)

In close collaboration with stakeholders during a series of two workshops in 2008, a selection was made of the most appropriate and feasible soil and water conservation measures to be implemented and monitored in DESIRE. Here we present the first implementation and monitoring results.

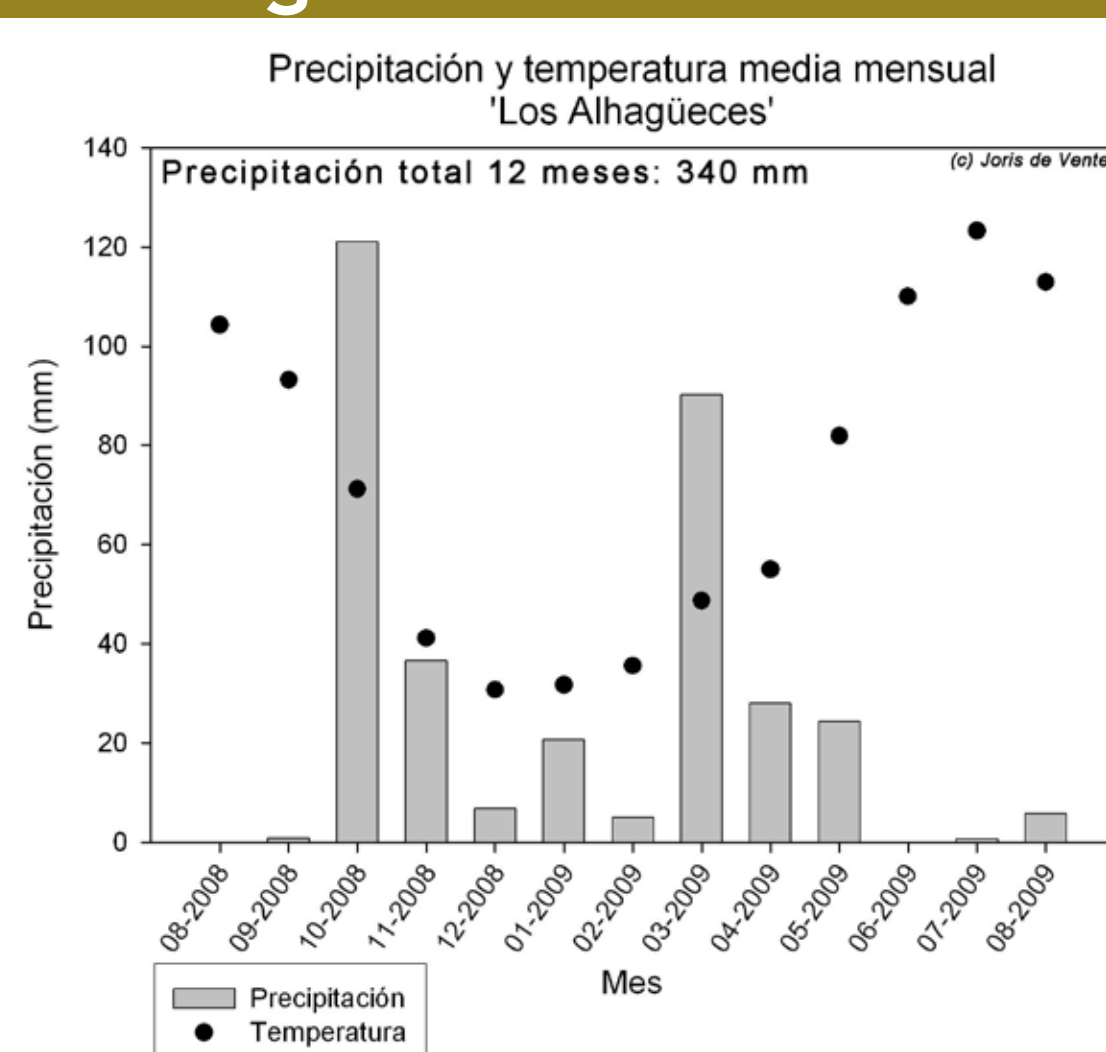
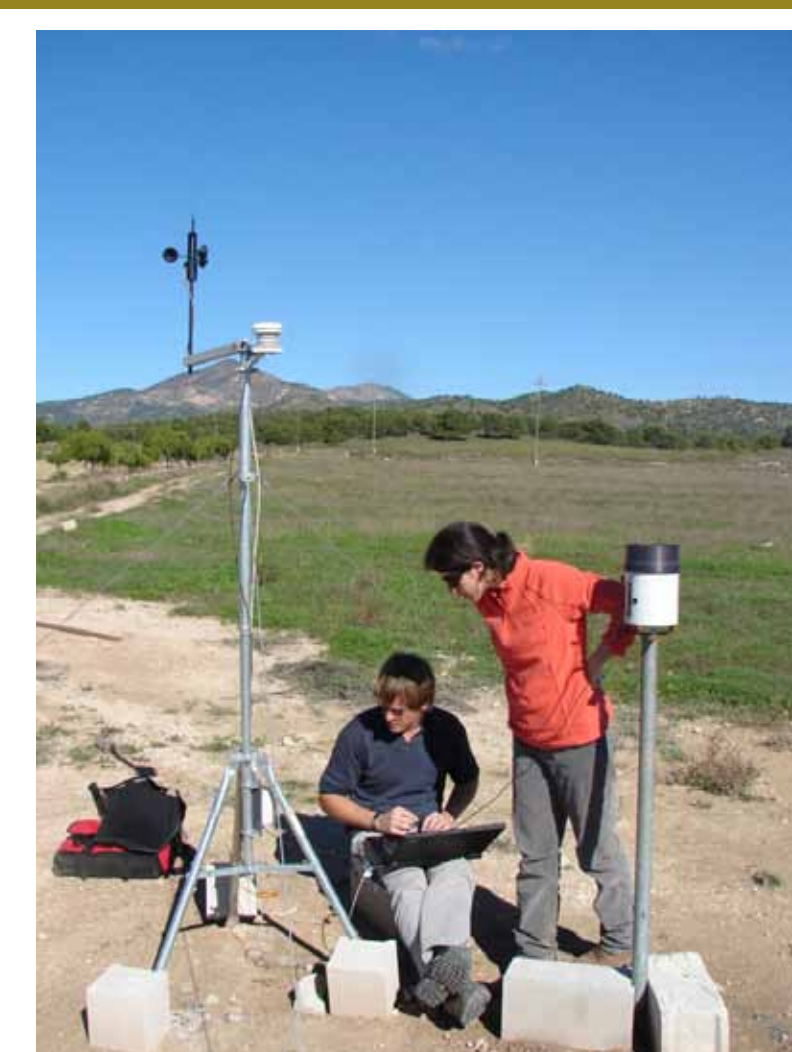
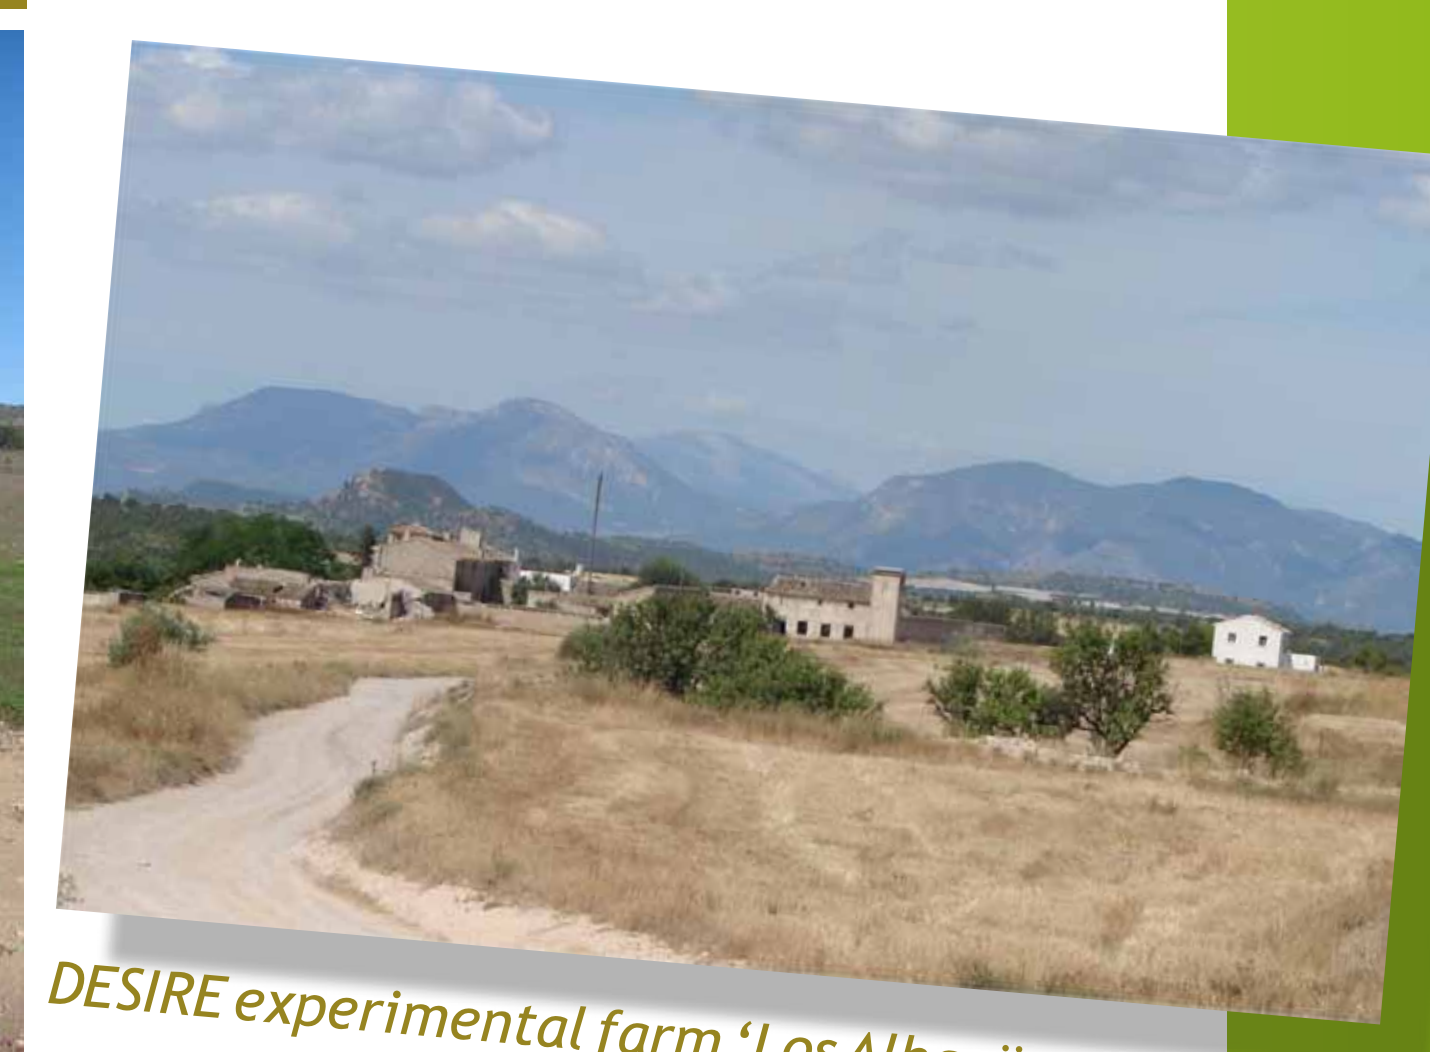
Figure 2: Overview of the mean monthly rainfall and temperature at the meteorological station 'Los Alhagüeces', 2008-2009.

Since August 2008 a meteorological station was installed near the field sites to monitor rainfall, temperature, wind direction and speed at a 5 minute interval. Figure 2 presents the mean monthly temperature and rainfall for the period of measurement.

The total annual rainfall of 340 mm is equal to the long term average. A maximum 5 minute rainfall intensity (I_{max}) of 108 mm/h was registered in May 2009.

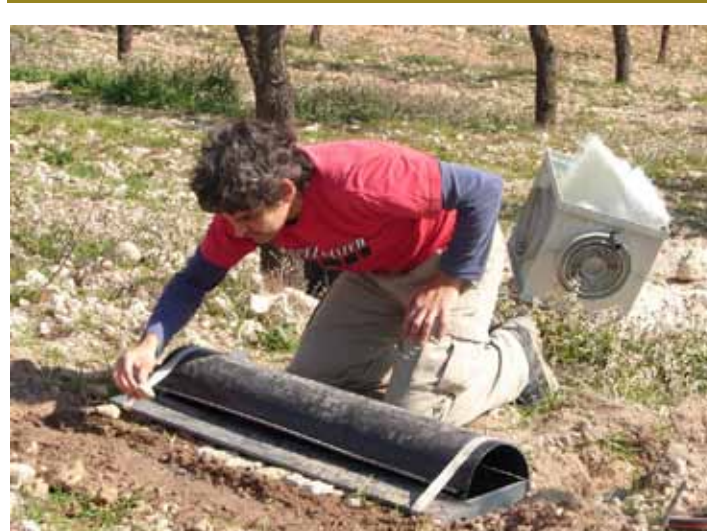
Installing Gertlach plots

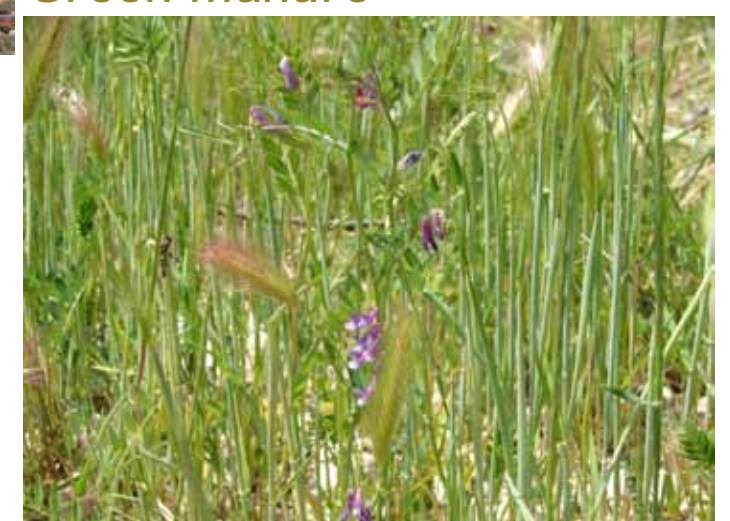
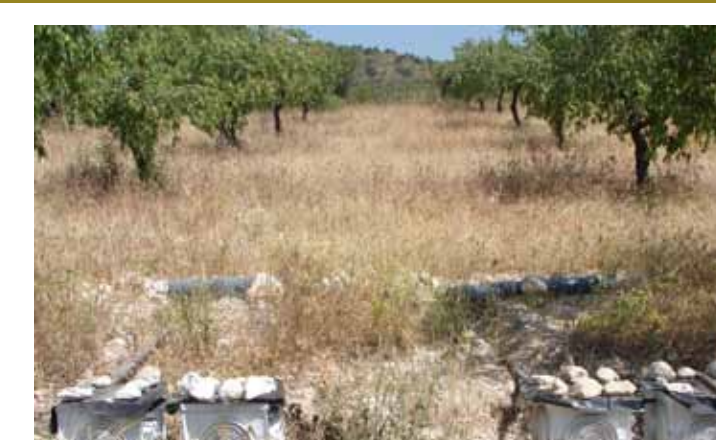
Green manure (a mixture of cereals and Vicia sativa) was seeded under the almond trees in October 2008. After mowing, the residue was ploughed into the soil in spring.

Green manure

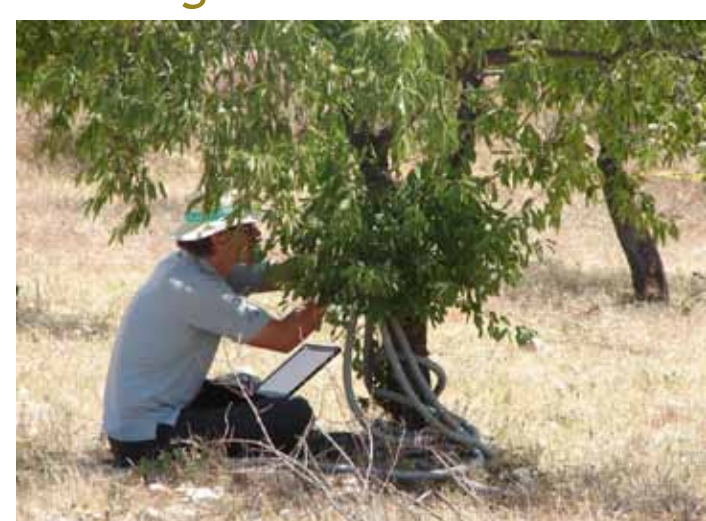
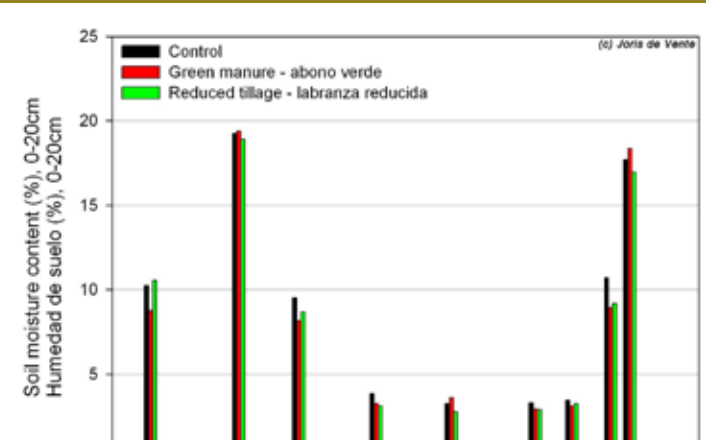
Runoff and erosion plots

In each of the production schemes, 3 replica erosion and runoff plots were installed to measure soil- and water loss. Soil moisture content is monitored at two depths (0-20cm and 30-35cm).

Reading out moisture data

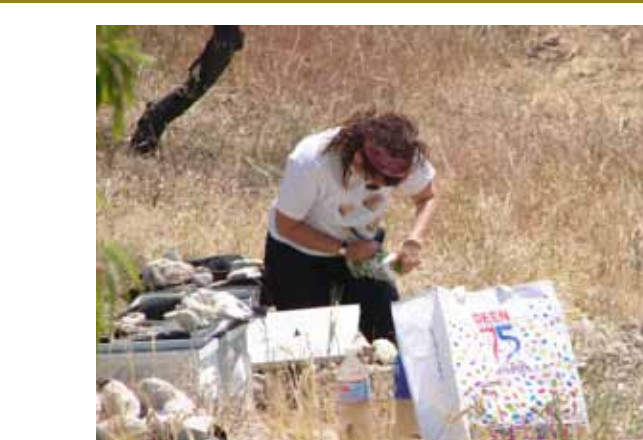
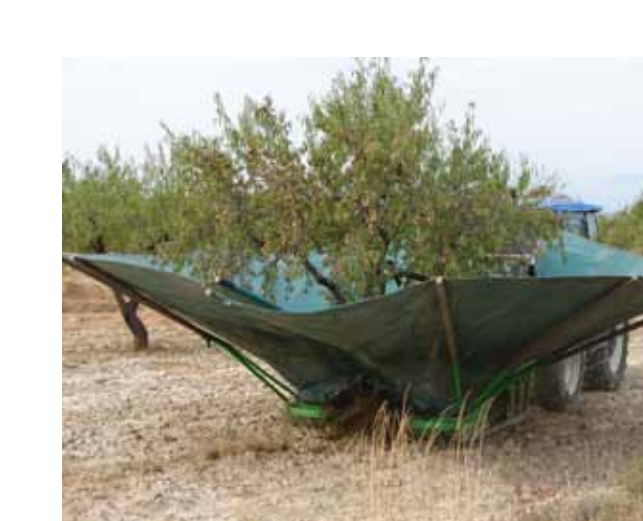
Collecting runoff, sediment and almonds

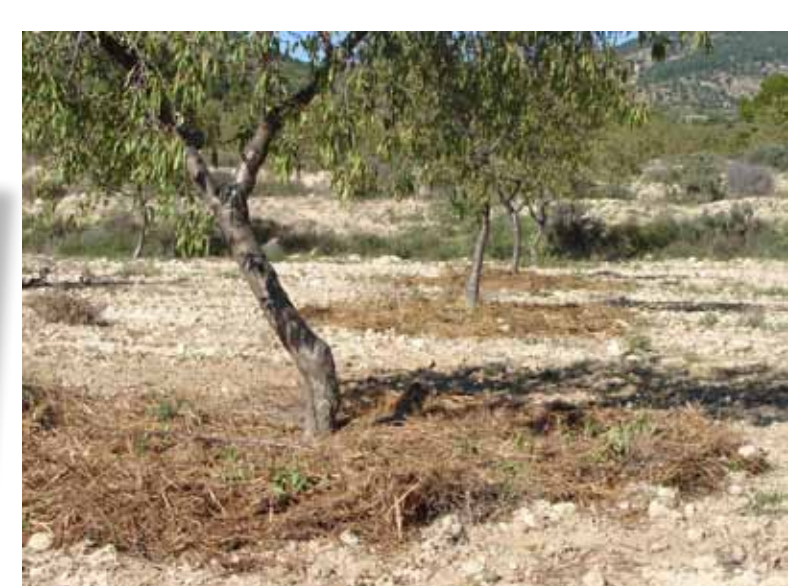
Straw mulch under almonds

Field site B consists of a series of almond terraces where the effectiveness of reduced water loss through an organic mulch is compared with the additional supply of water by water harvesting through a traditional Boquera-Acequia system.

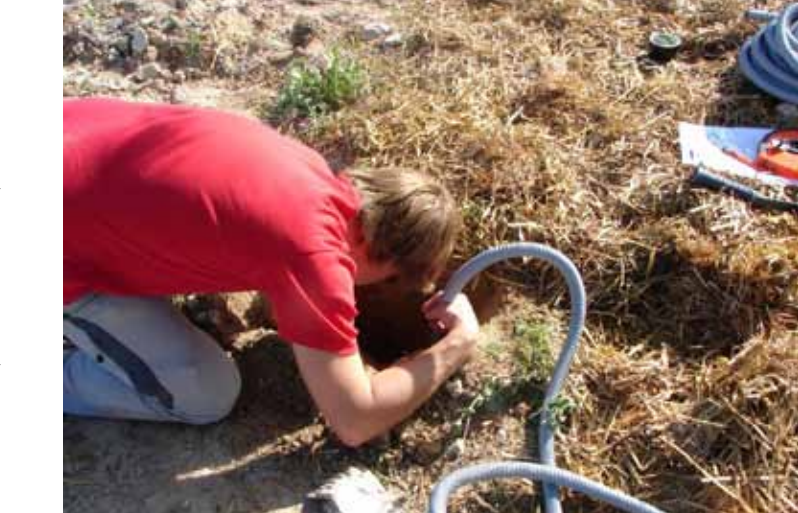
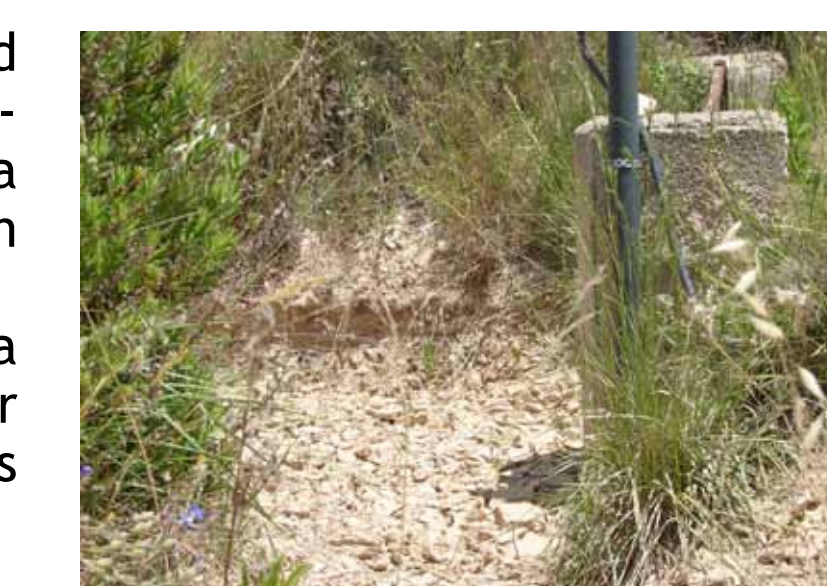
Installing soil moisture sensor

Boquera entrance with sensor

Water height at the inlet of the 'boquera' field is continuously registered in a section. Between August and September 2009 five events with water inflow were recorded.

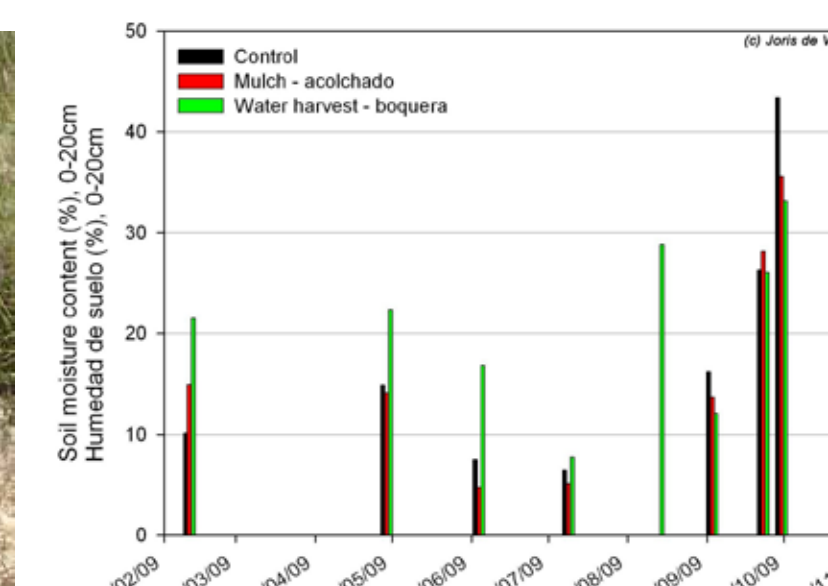
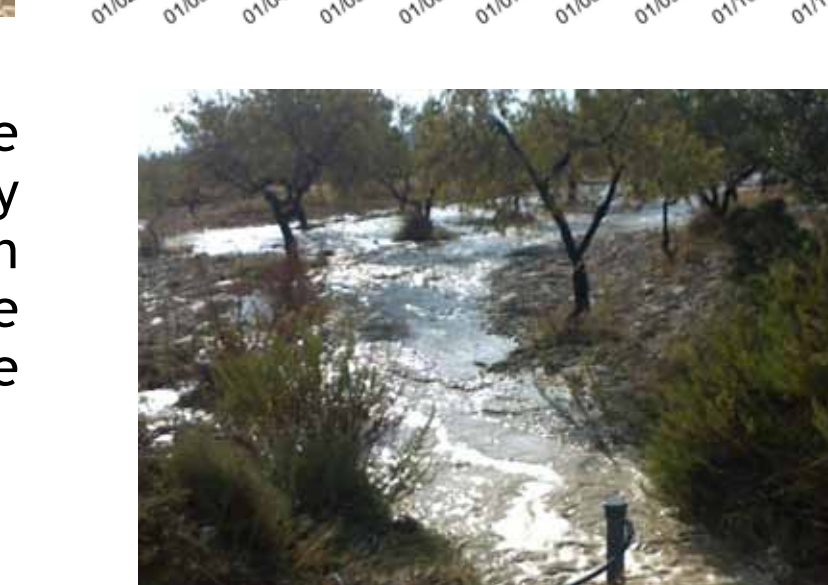
Water entering through the Boquera

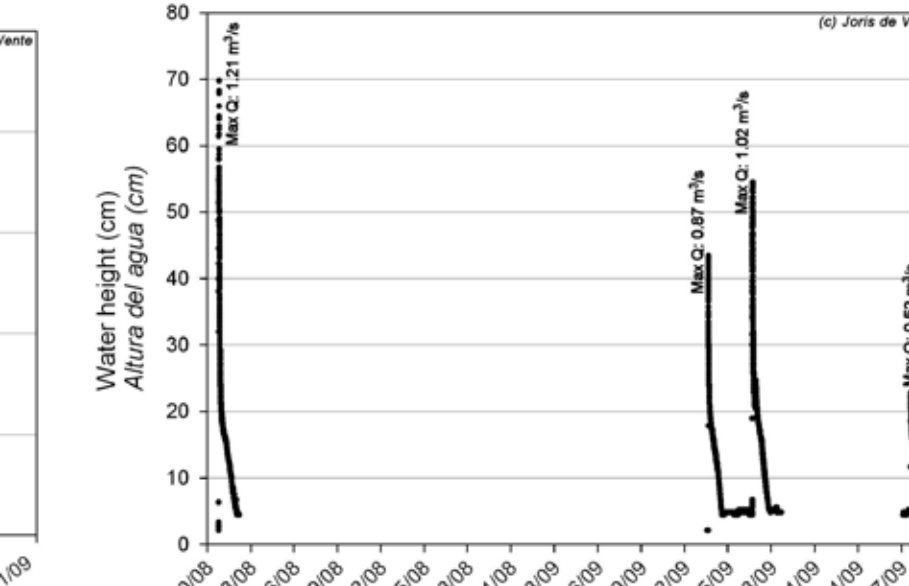
Registered events of water inflow in the Boquera

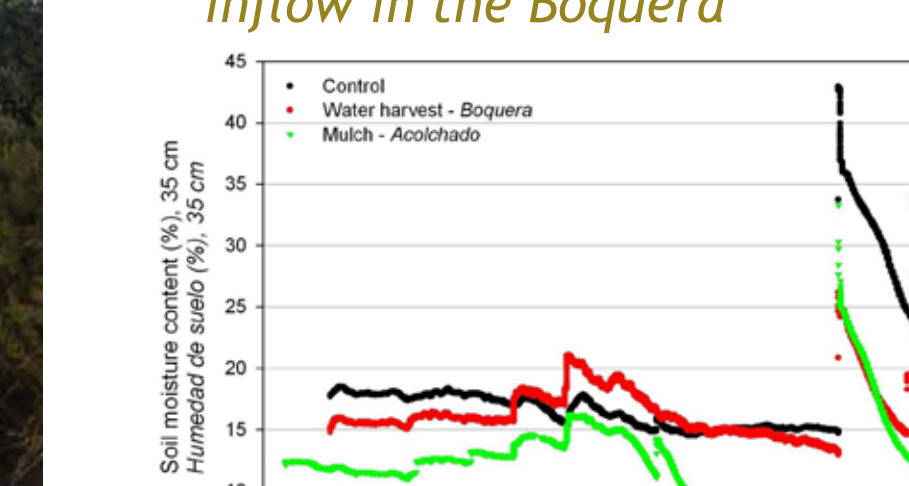
Soil moisture content (%) at 0-20cm and 30-35cm

Soil moisture content is monitored at two depths (0-20cm and 30-35cm) in a field with a mulch, a field with additional inflow from the boquera and a control field. The 2009 harvest showed a distinct higher production per tree in the Boquera field as compared to the other two.

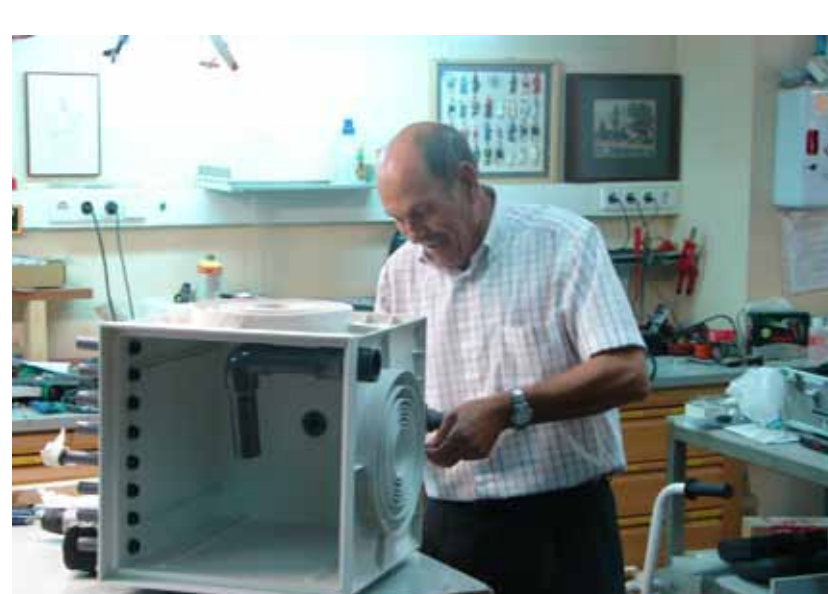
Construction of runoff storage tanks

Field site C is a cereal field where conventional mouldboard tillage is compared to reduced tillage with a disc-plough. Under both tillage regimes 3 replica erosion and runoff plots were installed to measure soil- and water loss. A fallow year follows harvest in both schemes. Last August the plots were seriously threatened by forest fire, but not affected.

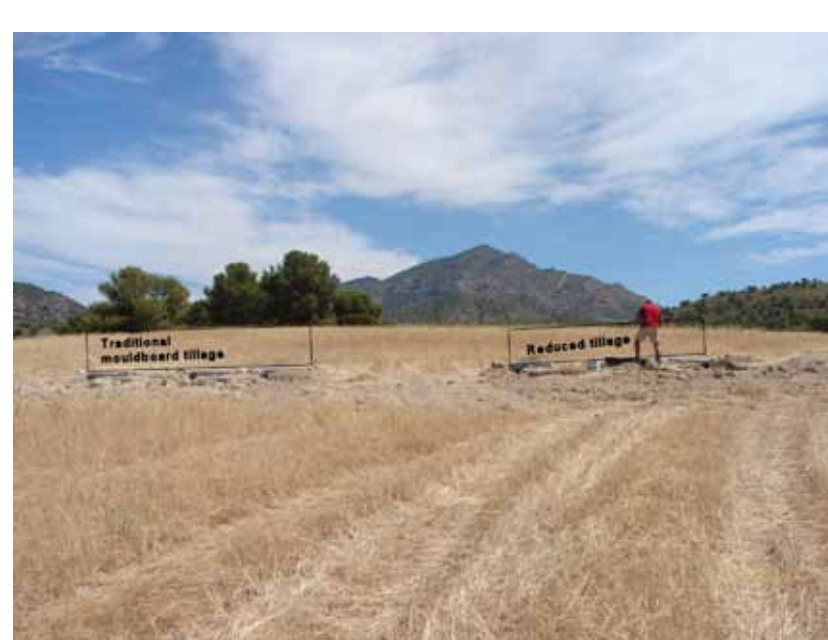
Runoff and erosion plots under cereal

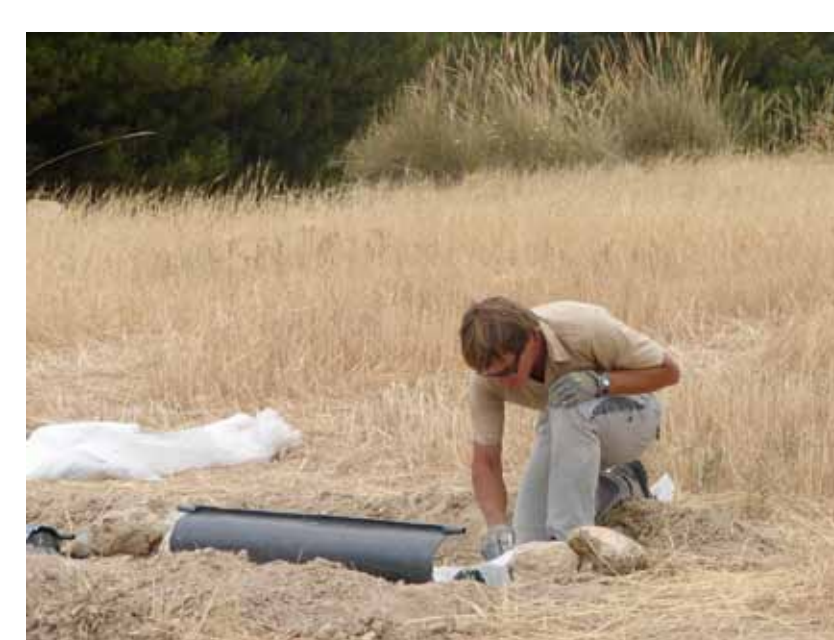
Installing runoff and erosion plots under cereal
